PUBLICATION NO: USAEPG-FR-922

6 PRODUCT IMPROVEMENT TEST

OF

RADIO TERMINAL SETS AN/TRC-117/151 AND AN/TRC-145

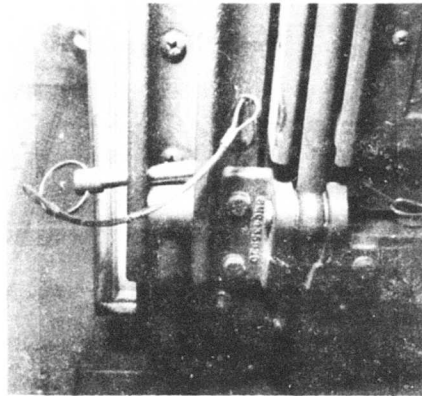
Figure 8. Door locked with pin.

(3) The device which holds the door open was awkward in operation. It required insertion of a pin to lock the door in the open position (Figure 8). The pin usually wedged at an angle as shown in the photograph and was difficult to remove. A simpler and more effective locking device was found on the AN/TCC-73 as shown in figure 9.
